Prairie Island Nuclear Generating Plant

Turbine Building Flooding
Regulatory Conference
July 13, 2010

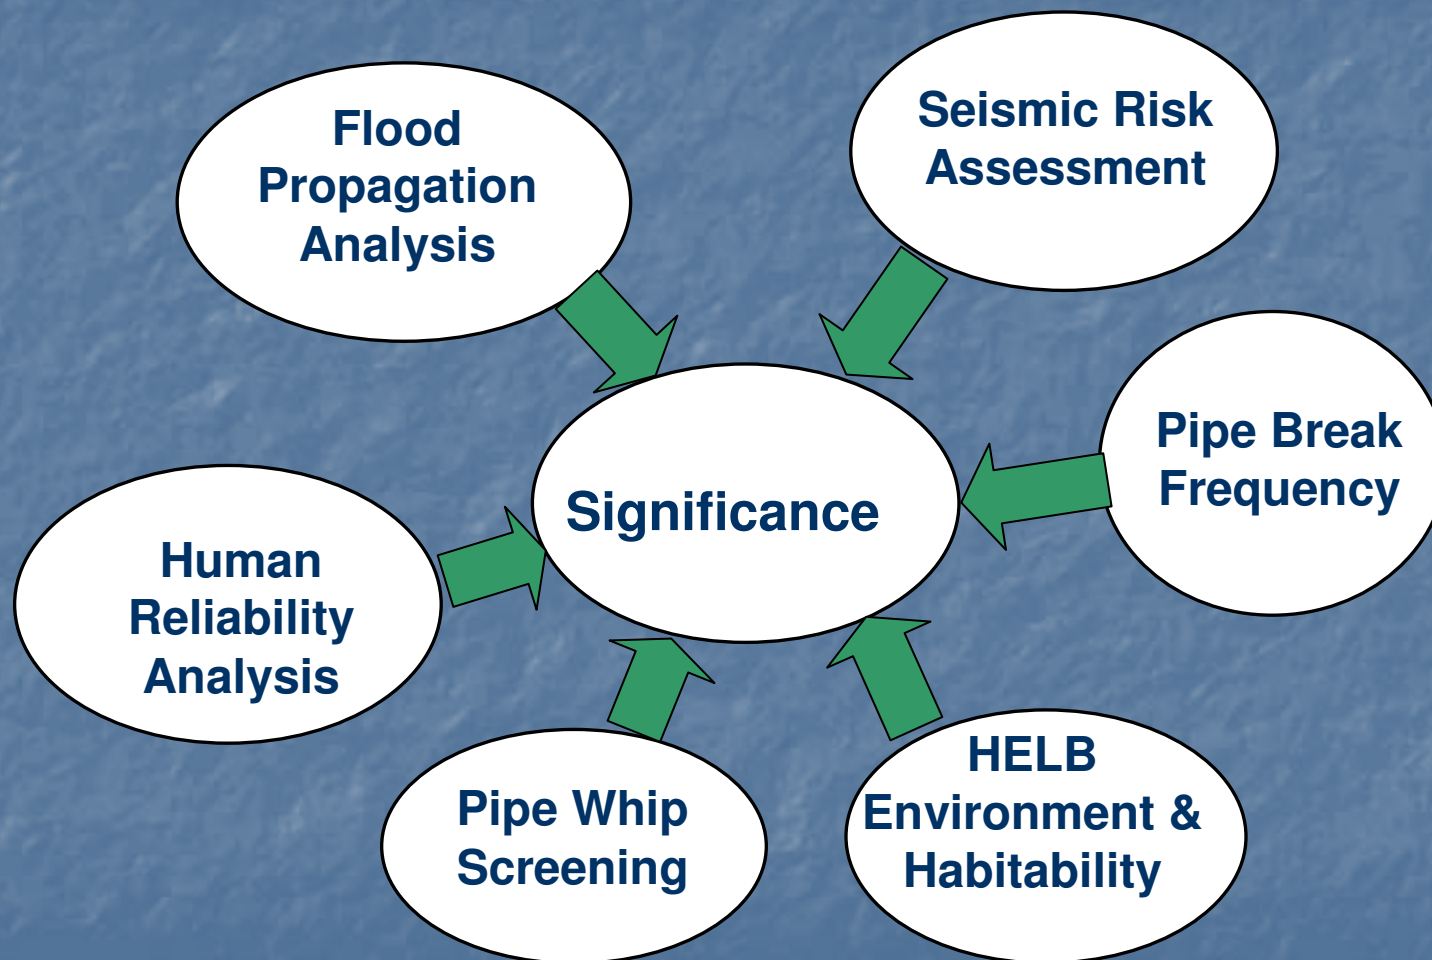
Internal Flooding Significance

- Delta-CDP in the low-to-moderate safety significance range
- Driven by seismic events beyond the design basis, and by moderately sized HELB interactions.

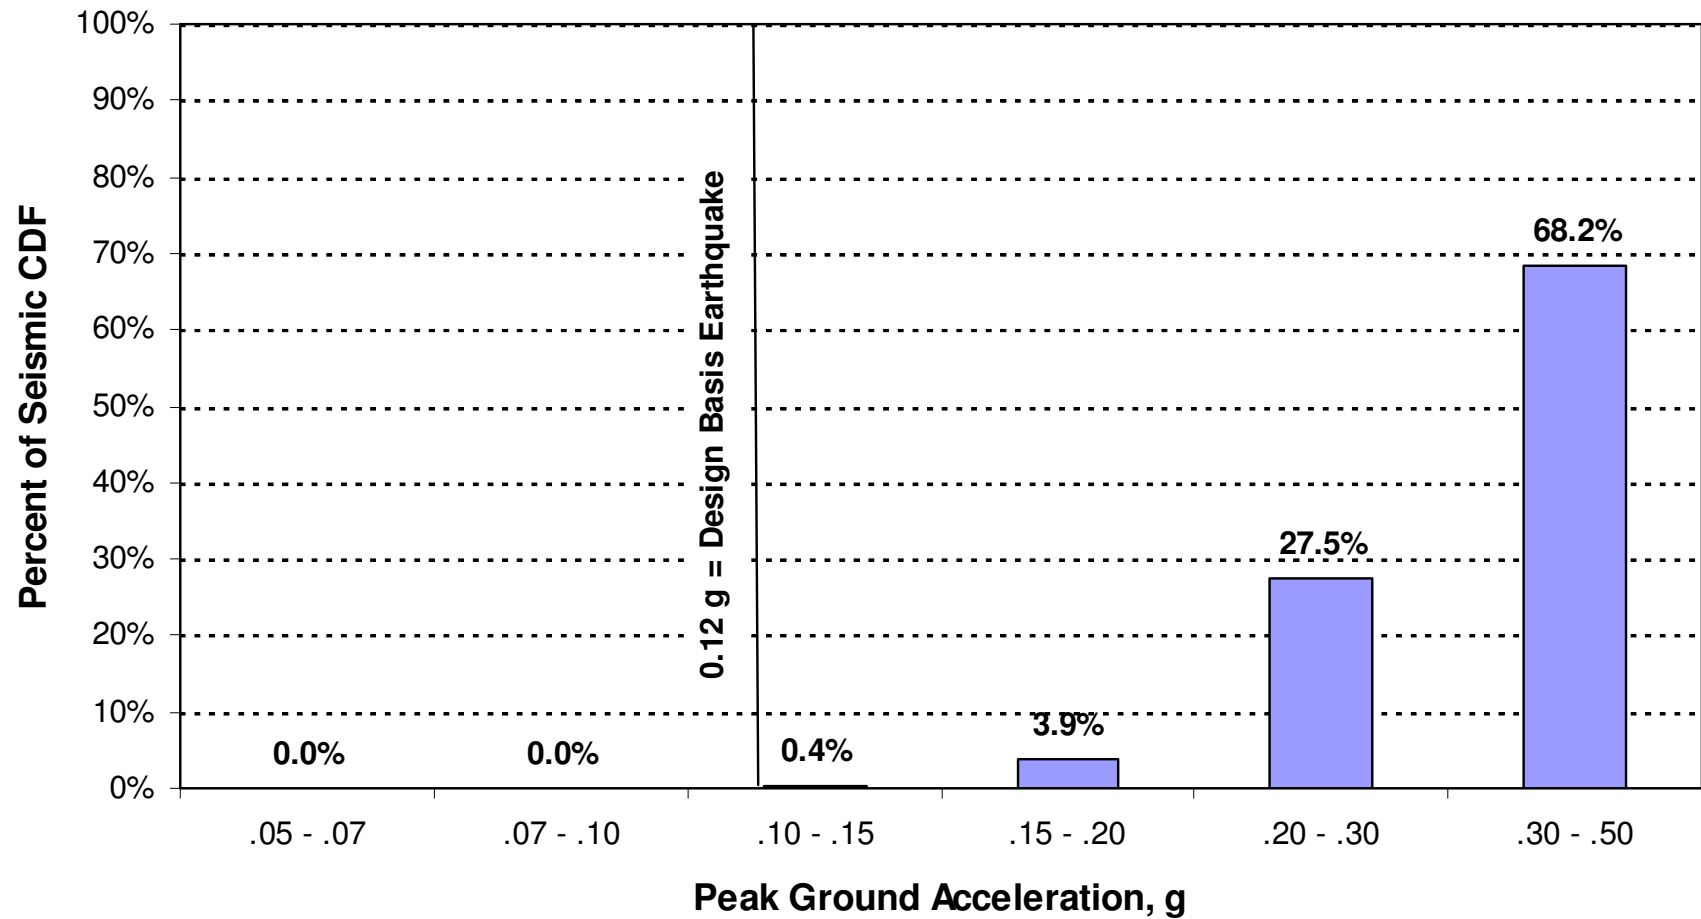
PINGP Unit 1 Turbine Bldg Seismic Flooding Risk (Total = 2.45E-6/yr)

- EPRI 1016736 Uniform Hazard Spectra.
- Walkdowns, Cooling Water, Fire Protection.
- >130 seismic fragilities assigned.
- Detailed analysis for important components.
- Offsite Power Availability.

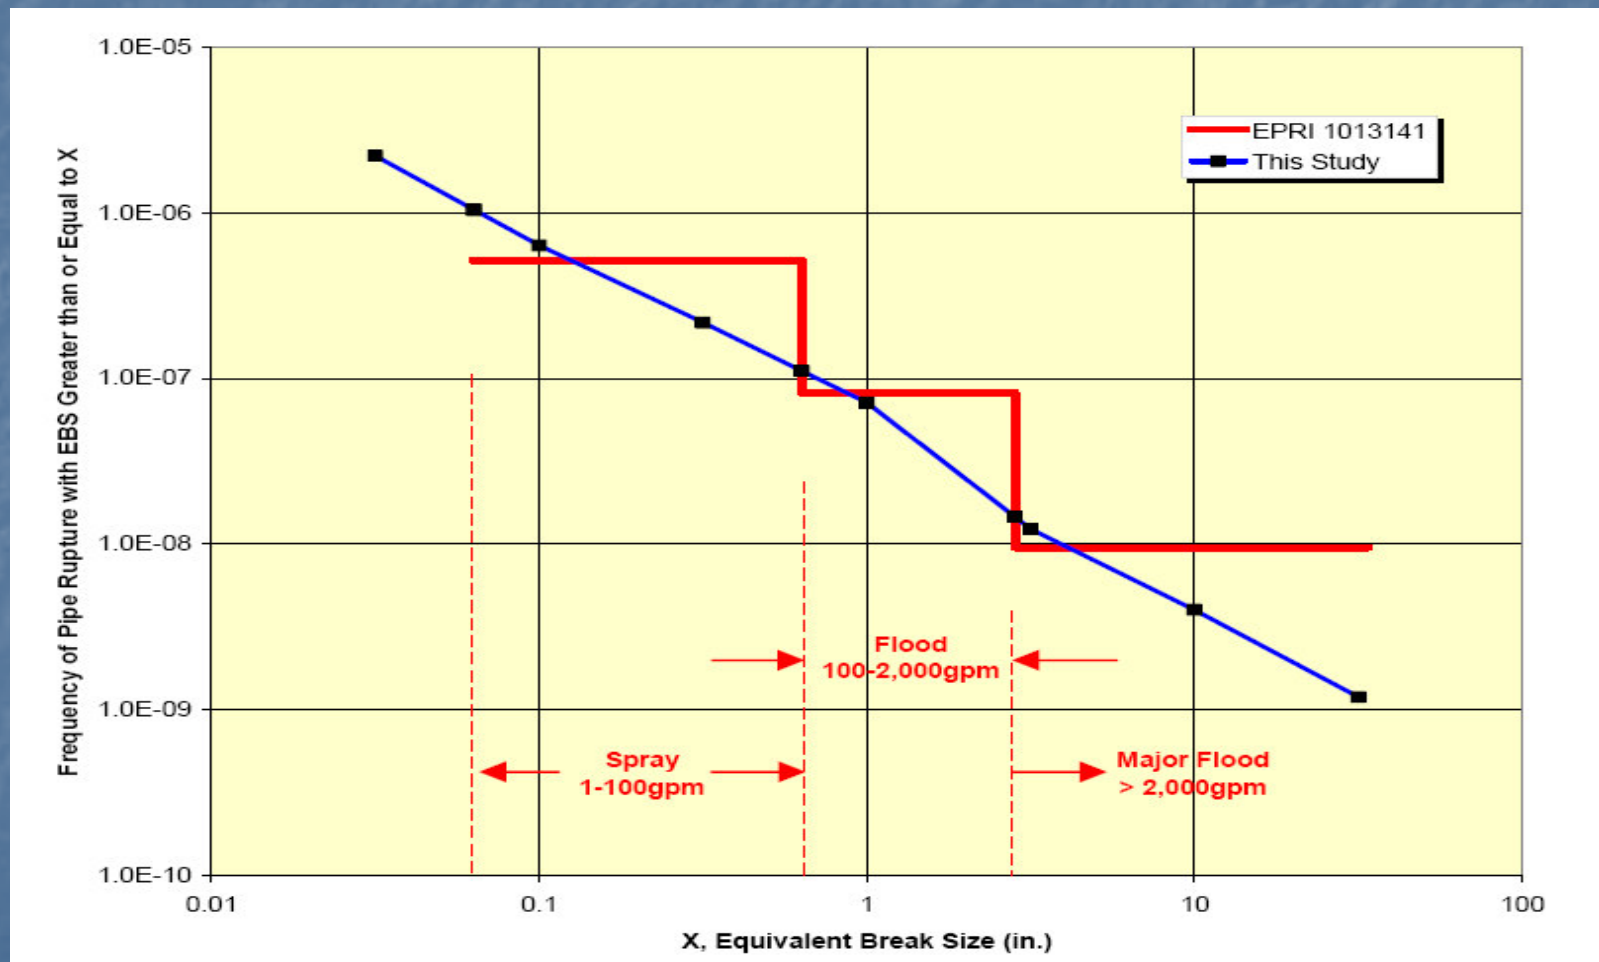
Failure Rates for River Water Line > 10"

- Used EPRI 1013141 data
- Continuous curve vs. stair-step.

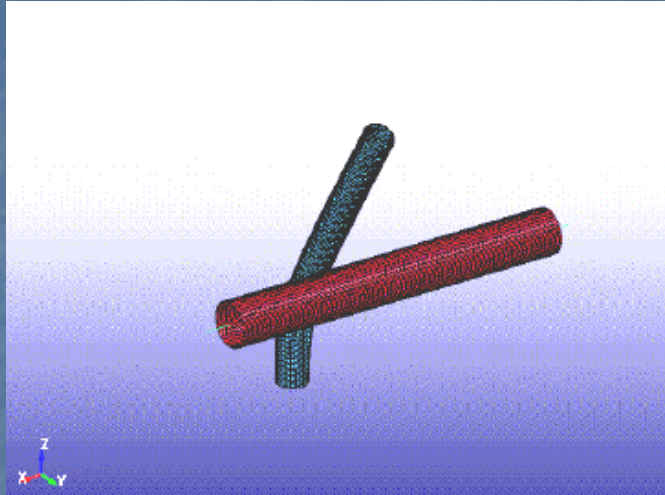
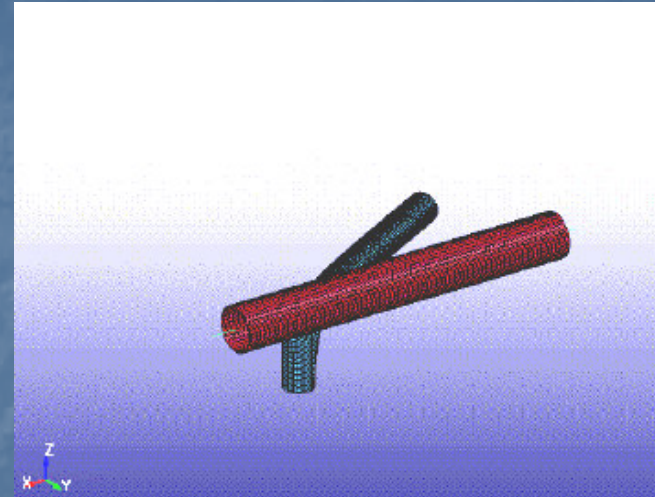
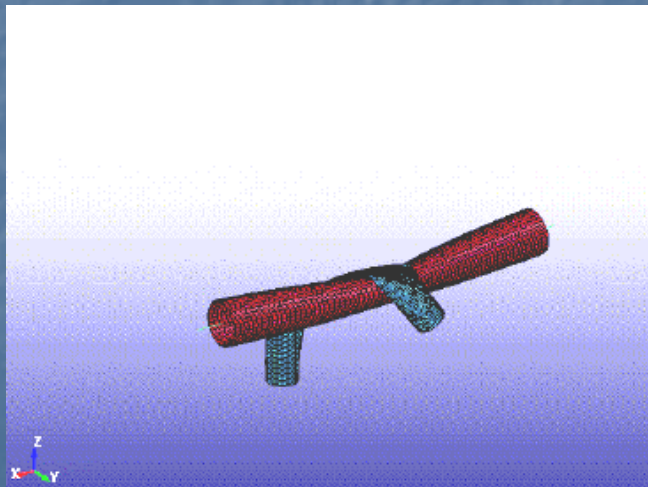
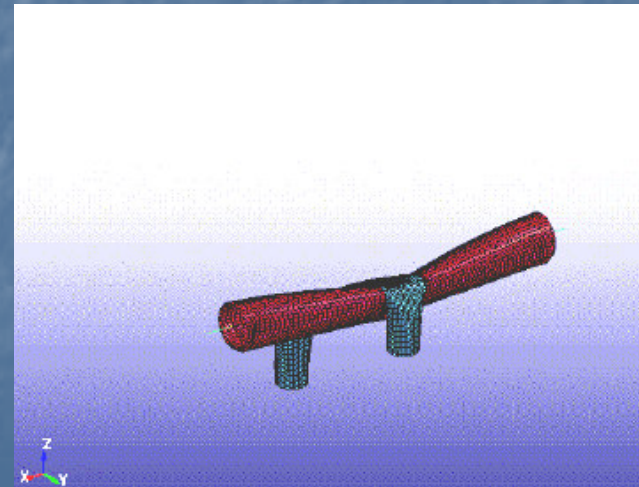
Pipe Whip Interaction – Case 5

- Consequences
 - Energy release – habitability
 - Fire sprinkler actuations
 - Blow-out panel actuations
 - Pipe whip interactions
- Modeled using GOTHIC (different model than flooding model)

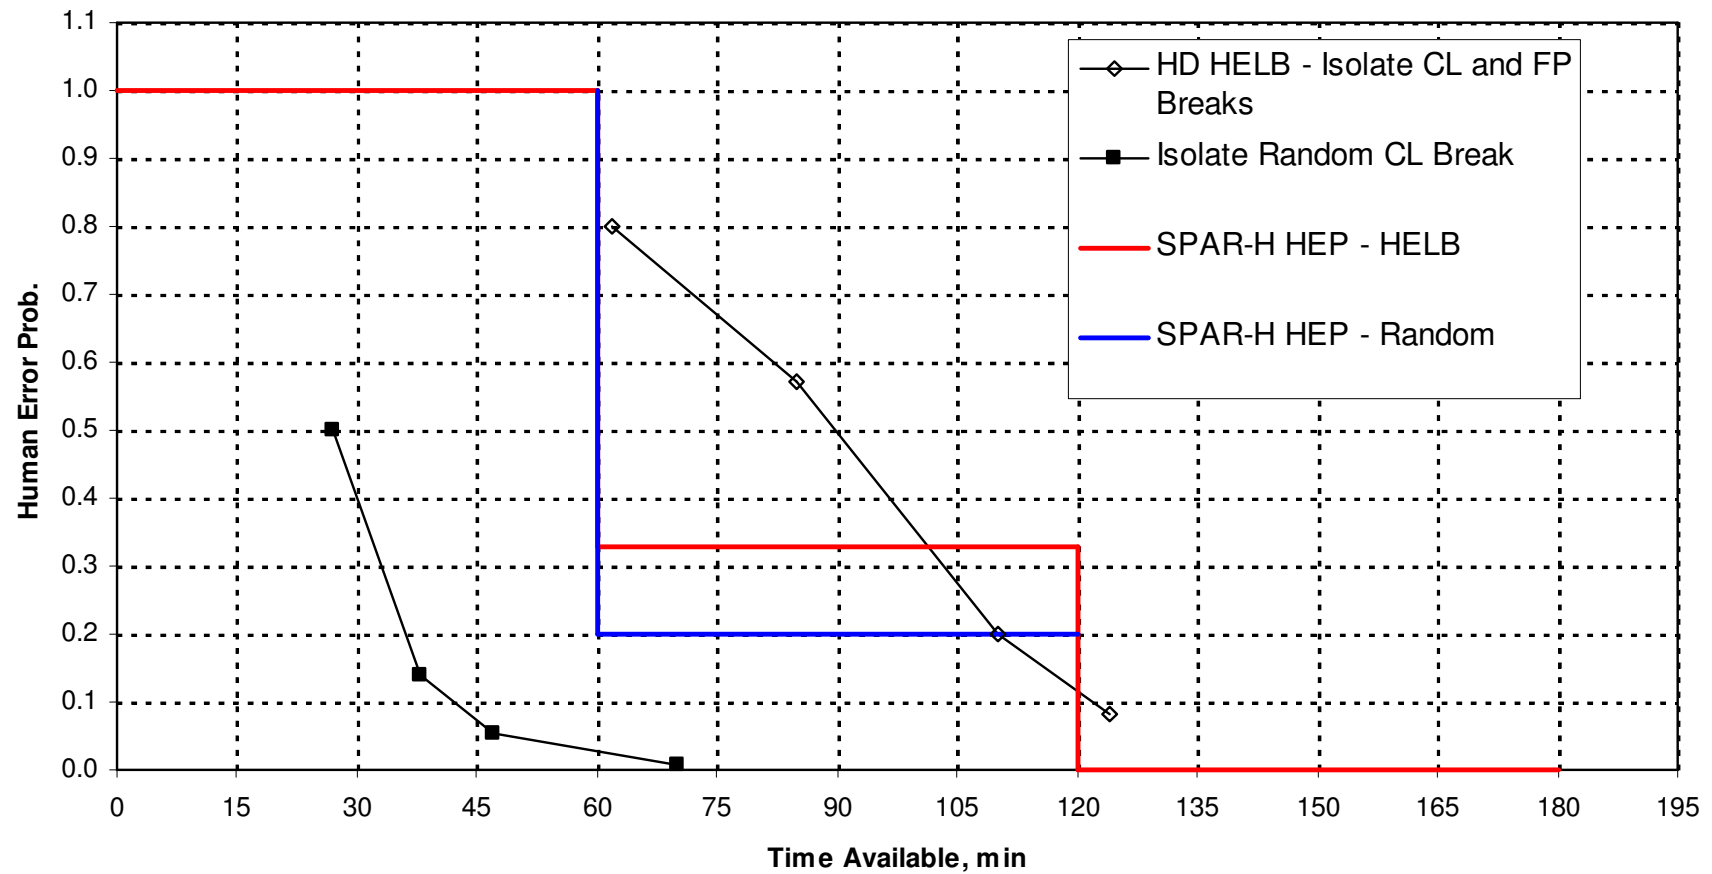
Influence of Challenges & Environment on HEP

- EPRI HRA Calculator Software
- Human Cognitive Reliability / Operator Reliability Experiment (HCR/ORE) method.
- 72 Different HEPs calculated.
